National Pollutant Discharge Elimination System Municipal Separate Storm Sewer System Permit

FY2017 Annual Report

Reporting Period:
July 1, 2016 to
June 30, 2017

Montgomery County, Maryland

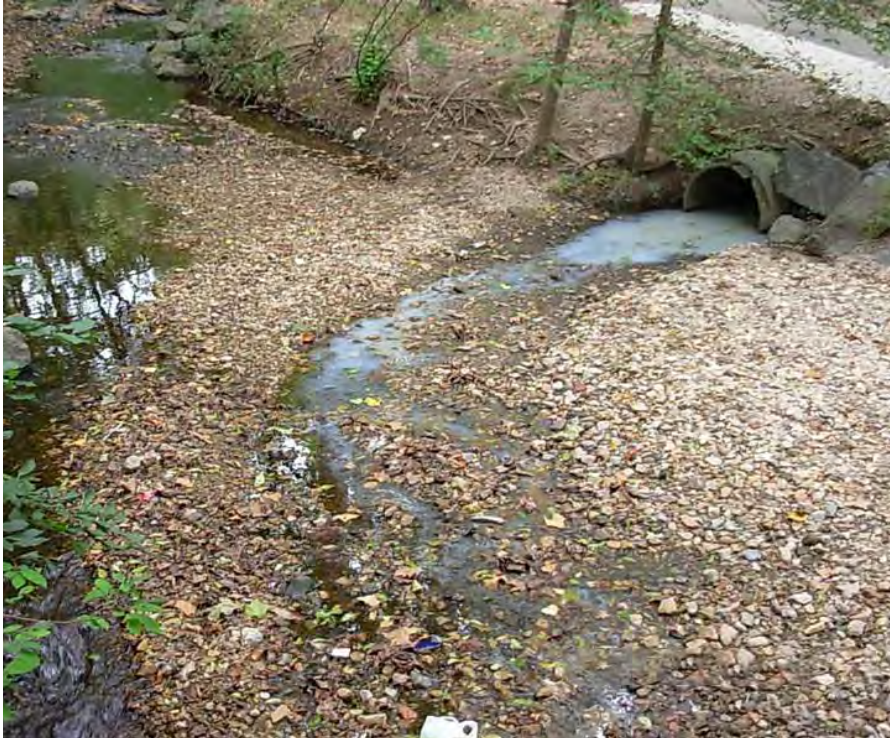
Outfall with milky discharge

Outfall Screening: DEP staff investigate all dry-weather discharges (non-stormwater) that are determined by field-testing to be polluted. These “illicit discharges” are then tracked to their sources and eliminated. In FY17, DEP screened 162 outfalls, found 27 outfalls with dry weather flows, and identified 64 new outfalls that were previously not mapped in the inventory.

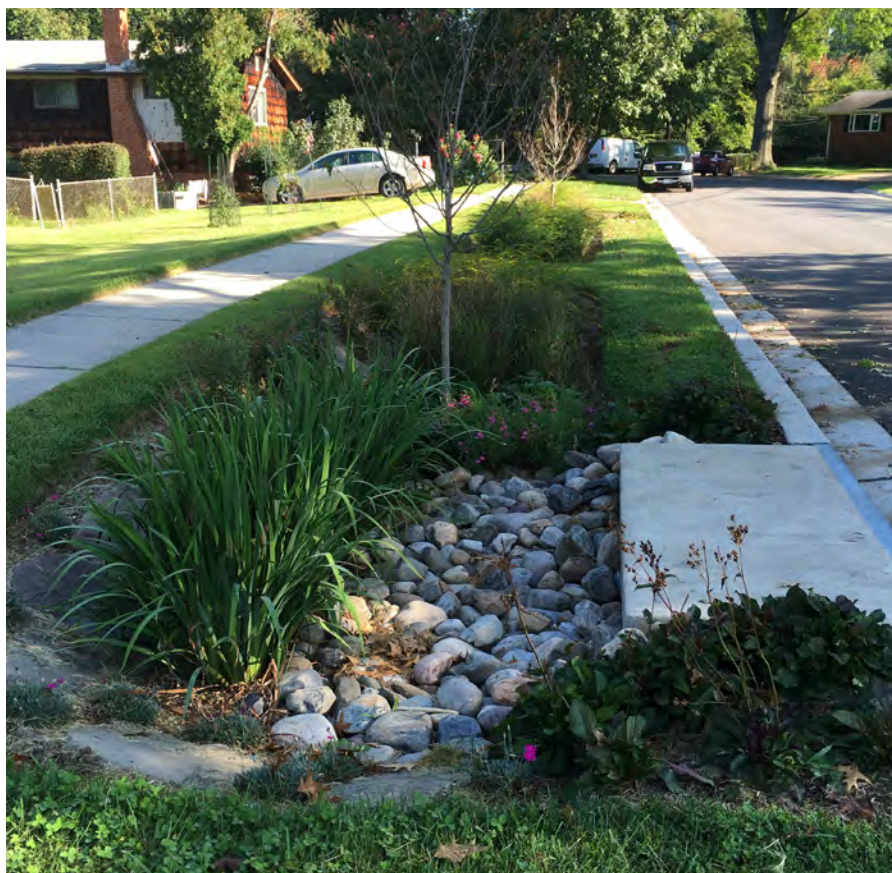
Green street Installed as part of the Breewood Tributary Restoration Project

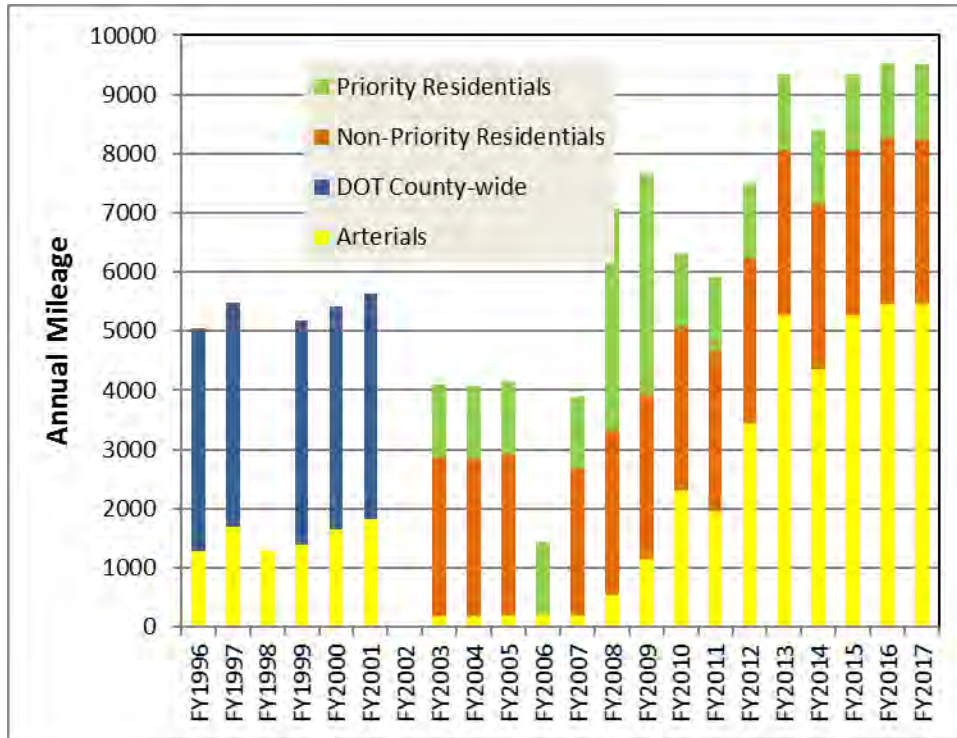
Figure III.E.9 Annual Montgomery County Street Sweeping Mileage 1996-2017

Figure III.E.9 shows the annual street sweeping mileage from FY99 to FY17. From FY96 through FY01 data were represented as arterials and DOT county-wide area. Starting in FY03, mileage of street sweeping on residential routes, both priority and non-priority, along with arterials are presented (Figure III.E.9).

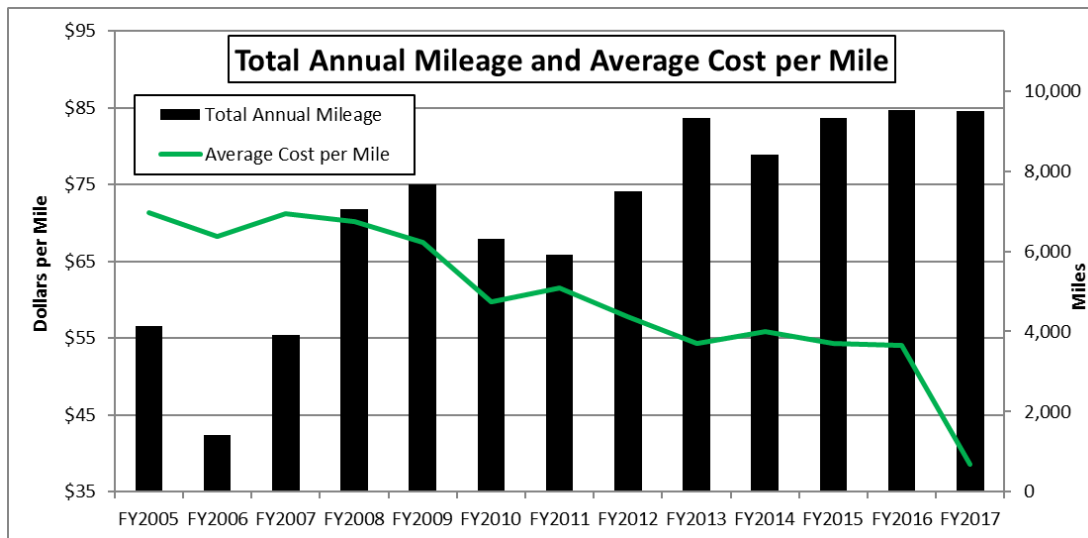
Figure III.E.10 Montgomery County Street Sweeping Mileage and Average Cost 2005-2017

Figure III.E.10 shows the annual street sweeping mileage and average cost per mile for the program from FY05 through FY17. The cost of the program decreased over time with notable decline in FY17 mainly due to change in the contractor.

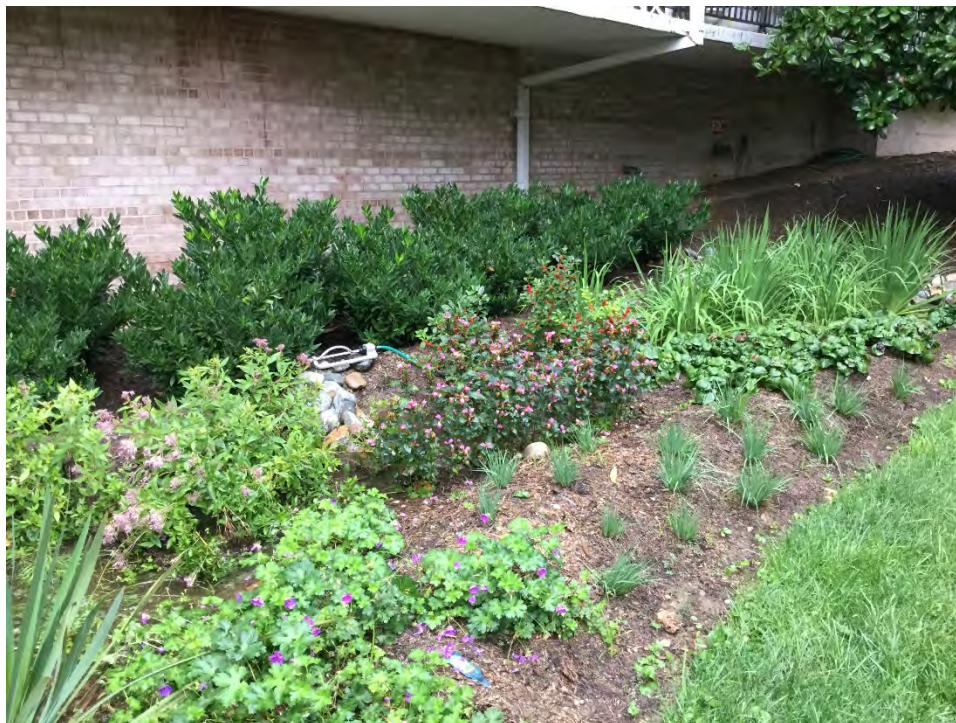
Figure III.G.7 The Waterford Condominium project: Fall of FY17 was filling in well after being installed in the Spring of FY16. This project demonstrated newer building techniques for rain gardens and is managing 2,700 SF of roof area.

The Waterford Condominium project, a RainScapes project installed in FY16, demonstrated newer building techniques for rain gardens and is managing 2,700 square feet of roof area.

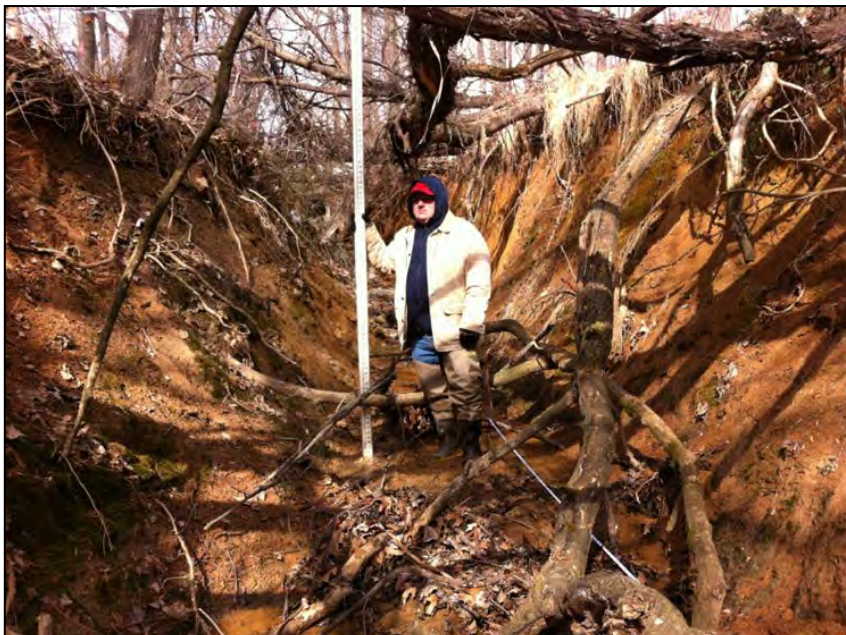
Figure III.H.10 Upstream View of Sligo Creek - Breewood Tributary, Study area 1, Pre-Restoration (2013)

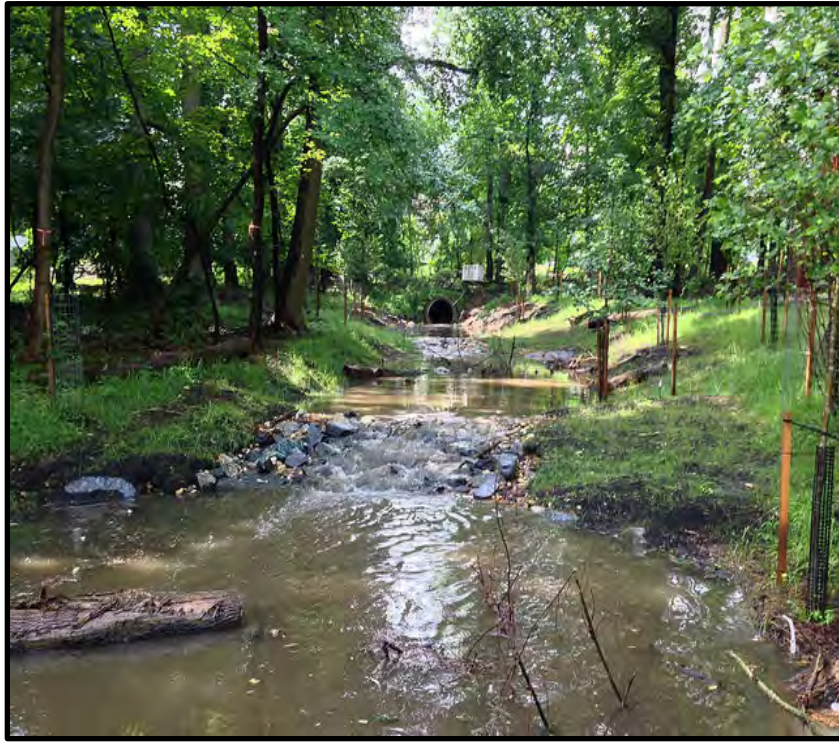
Figure III.H.11 Upstream View of Sligo Creek, Breewood Tributary, Study Area 1, Post-Restoration (2015)

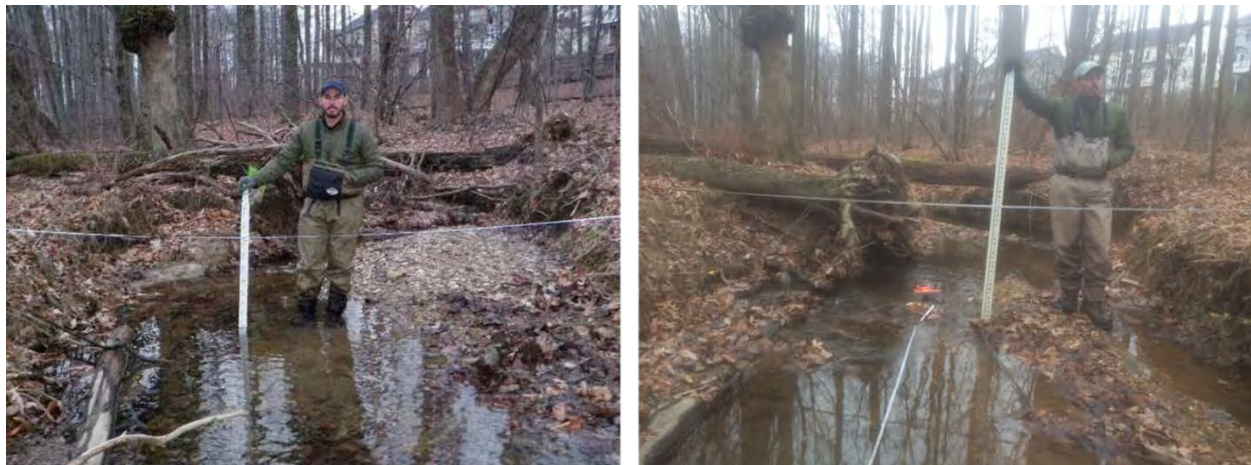
Figure III.H.16 Comparison between Newcut Rd Tributary test area 4 cross section 2015 (left) and 2016 (right)
